Auger Electron Spectroscopic Analysis of Filler Densification-Induced Interfacial Fracture in Polymer Particulate Composite System

¹Central Engineering & Development and ²Failure Analysis Group
STMICROELECTRONICS, INC., 9 MOUNTAIN DRIVE, LISP II, CALAMBA 4027 LAGUNA, PHILIPPINES

Abstract— Component failure due to the interfacial adhesion loss is a serious concern in advanced semiconductor packages. Herein, we report the systematic failure analysis performed on a system where one component detaches from the assembly due to the adhesion loss between the base material and the glue. Surface analysis of the fractured surface via scanning electron microscopy – energy dispersive X-ray spectroscopy (SEM-EDS) elemental mapping and Auger electron spectroscopy (AES) revealed that the component failure is due to the densification of the filler in the epoxy-based polymer particulate adhesive. AES depth profiling indicate softening of the base material surface during thermal treatment and/or the mutual solubility with the glue causing the localization of CaSiO_3 at the interface. The densification resulted in the creation of an epoxy-rich meta-stable zone and a filler-rich layer, which reduces

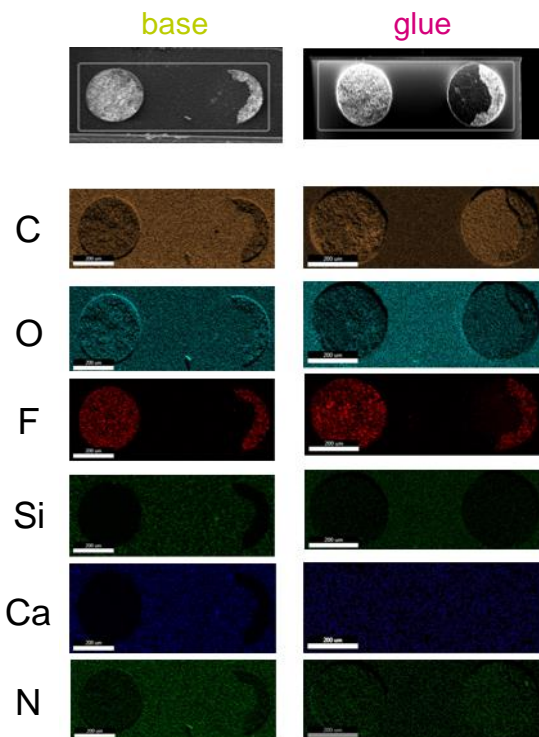
Fig. 3. Elemental mapping of the detached surface on the base material side (left) and the glue side (right).

Elemental mapping (Fig. 3) generated using SEM-EDS are consistent with the material composition. Interestingly, the proprietary component of the glue contains fluoroalkyl substituents, making it a distinctive feature of the glue material. Hence, the presence of F is an indication of the presence of the glue material. In contrast, Ca is the only component that selectively identifies the presence of the cap material.

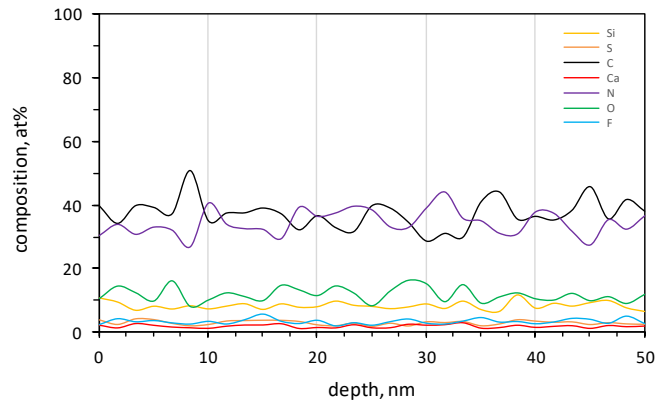
Fig. 4. AES depth profile of the base material surface. Inset: SEM micrograph of the analyzed surface.

Results from the base material at the fracture plane suggest homogeneous composition within the 50 nm surface slab (Fig. 4). More importantly, these results indicate that the fracture plane is within the base material layer.

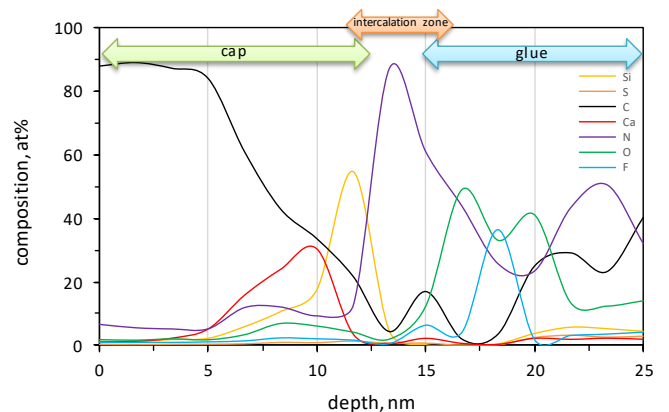
Fig. 5. AES depth profile of the glue surface. Inset: SEM micrograph of the analyzed surface.

AES results from the glue surface (Fig. 5) indicate remnants of the base material. Elemental depth profile indicate that the fracture plane is mainly organic (5 nm) with Wollastonite (CaSiO₃)-rich layer (7 nm) present near the intercalation zone. A 5 nm intercalation zone exists 12 nm from the surface. This intercalation zone is responsible for the

adhesion strength between the polymer of the base material and the glue. It is apparent from the results that the filler material is densified near the fracture plane, suggesting that this densification reduces the resistance of the interface to thermomechanical stress [6]. The softening of the cap surface during thermal treatment and/or the mutual solubility with the glue material causes the localization of CaSiO_3 at the interface. The higher filler content means that the epoxy content is lower, and hence less material that acts as dispersing medium. In addition, the filler-to-filler contact is higher resulting in weaker resistance to mechanical stress [7-8].

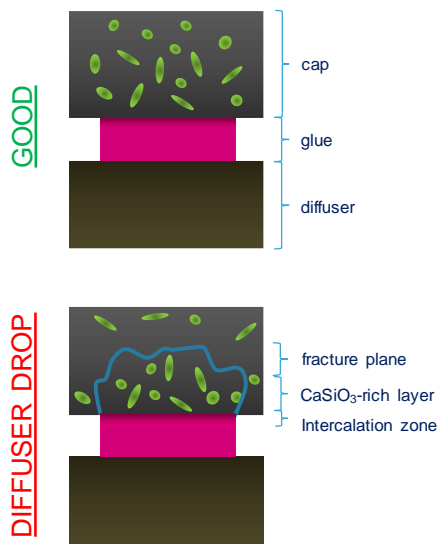
Fig. 6. Proposed mechanism of the filler-densification induced fracture.

The failure mechanism deduced from the results is shown in Fig. 6. In good assemblies, the filler is well dispersed in the epoxy matrix; hence, we speculate that PPC has higher resistance to thermomechanical stresses. The epoxy matrix acts as a cushion to prevent the fracture. However, in the case of the failing units, the densified filler creates a brittle layer sandwiched between the intercalation zone and the epoxy-rich glue matrix. The intercalation zone is expected to be strong because of the polymer (base material)-to-polymer (glue) compatible interaction. However, the interface of the brittle layer and the epoxy matrix (soft) is expected to be weak due to

the hard to soft sharp transition in the material's micro-environment. This weakness translated to fracture, and by extension component failure.
