# Fingerprints of Epoxy Bleed-out on Porous Ceramic Surface

Ian Harvey Arellano

Central Engineering & Development, Backend Manufacturing and Technology  
STMICROELECTRONICS, INC., 9 Mountain Drive, LISP II, CALAMBA 4027 LAGUNA, PHILIPPINES

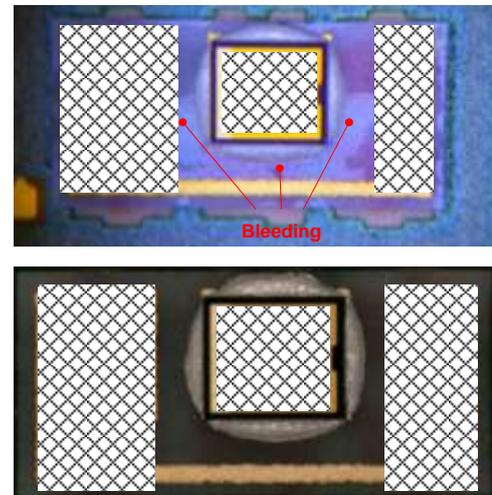
EBO was detected after the die attach process and staging during the assembly process. The bleed-out is visible in a scope surrounding the periphery of the glue mound as indicated in Fig. 1. The bleed-out mark disappears after oven curing. FTIR, SEM-EDS and TOF-SIMS analyses were performed to elucidate the fingerprints of the EBO on the porous ceramic surface.

Fig. 1. EBO marks after the glue attach process and staging (top) and after the oven curing (bottom). Portions not crucial to the analysis were redacted due to the proprietary nature of the product.

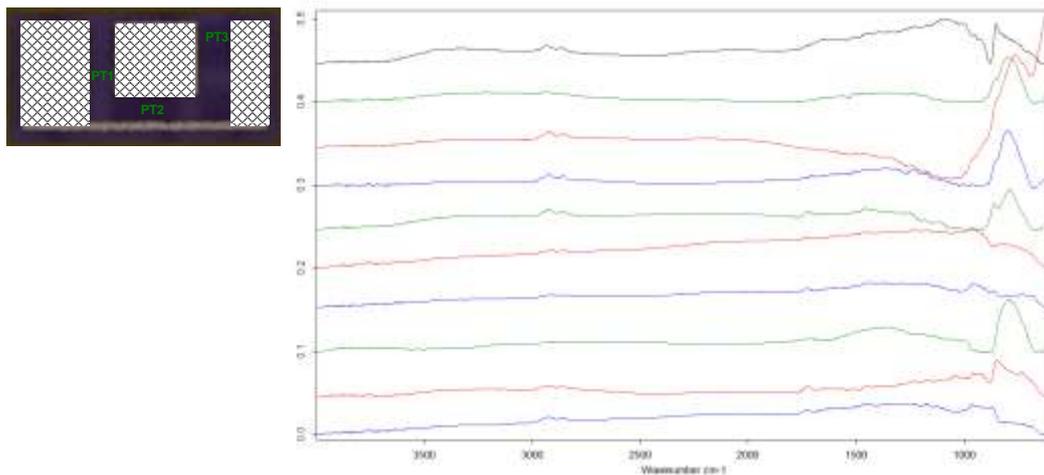
Fig. 2 shows the stacked spectra of two processed samples, one fresh surface, and the reference glue material. PT1 & PT2 in Samples 1 & 2 correlate with the glue material (71-76%). PT3 does not match with the glue but matches with the fresh surface, indicating that PT1 & 2 are within the bleed-out area.

Fig. 2. FTIR spectra of samples and references. From top to bottom of the stack: glue, PT3 – fresh, Sample 2 & 1, PT2 – fresh, Sample 2 & 1, and PT1 – fresh, Sample 2 & 1. Reference image indicating PT1, 2 & 3 is included in the upper left side of the image.

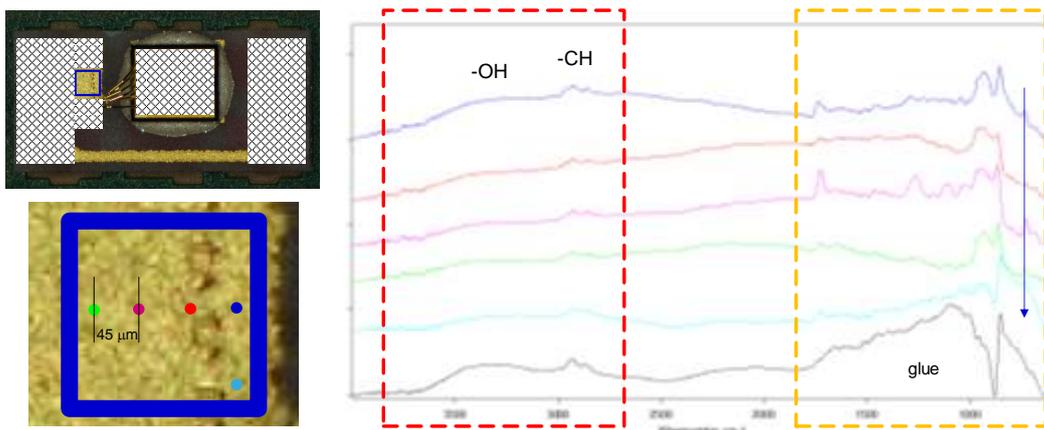
Fig. 3. FTIR spectra of the bonding area.

To assess the potential effect on the wirebonding process, the bonding area was analyzed. Spectra from the bond pad does not match spectrum of the glue (Fig. 3). Spectral region between 2800 and 3200  $\text{cm}^{-1}$  could not discriminate among the organics, hence is seldom used to understand differences between materials. The region between 3200 and 3500  $\text{cm}^{-1}$  corresponds to  $-\text{OH}$  stretch, which can come from the adsorbed  $\text{H}_2\text{O}$  and is not usually used as basis for determining differences between materials. The fingerprint region ( $<1000 \text{ cm}^{-1}$ ) is the more significant area for comparison. The peaks present in this region does not match peak profile of the reference glue, suggesting that the EBO did not reach the bonding area.

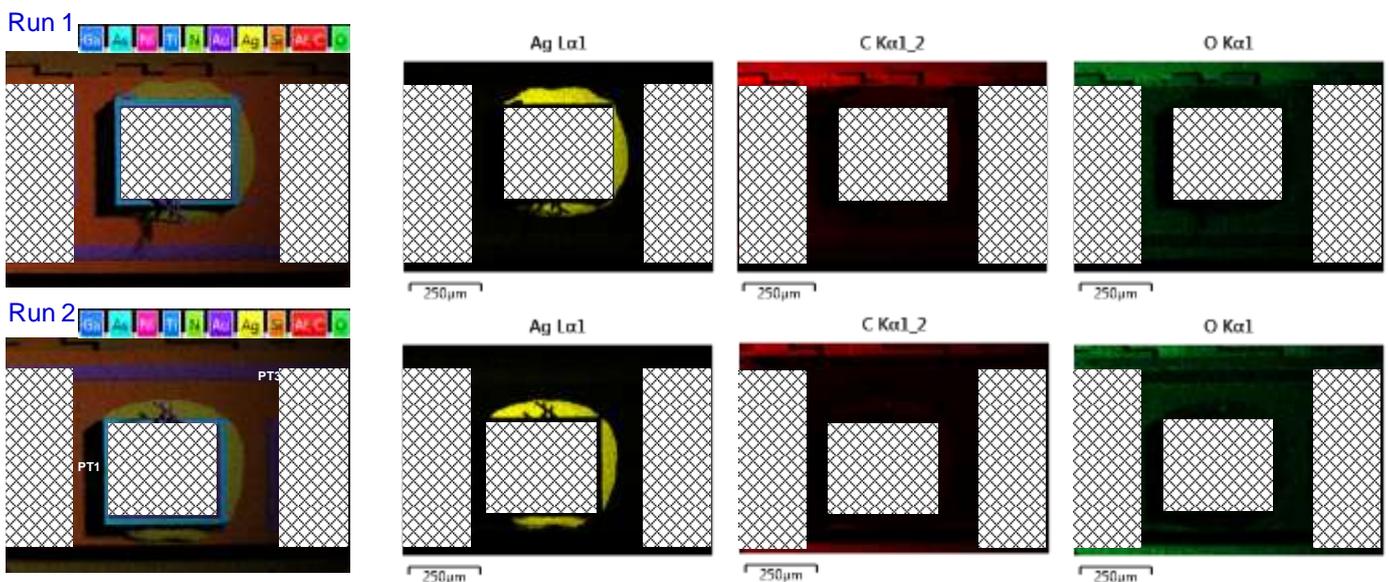
Fig. 4. EDS elemental maps.

FTIR analysis suggested the presence of glue on the ceramic surface, but not on the bonding area. To assess if conductive traces (Ag) dissipated from the glue mound, SEM-EDS analysis was done. The presence of conductive traces on the ceramic surface could potentially lead to electrical shorting, a product functional failure. Possible organic remnants (C, O) were observed on the ceramic area even after oven cure. TOF-SIMS analysis is suggested to check if C, O is organic or just part of the ceramic ( $\text{Al}_x\text{O}_y\text{N}_z$ ). No indication of

Ag, C and O on the bond pad validating the results of the FTIR analysis that the EBO did not reach the bonding area.

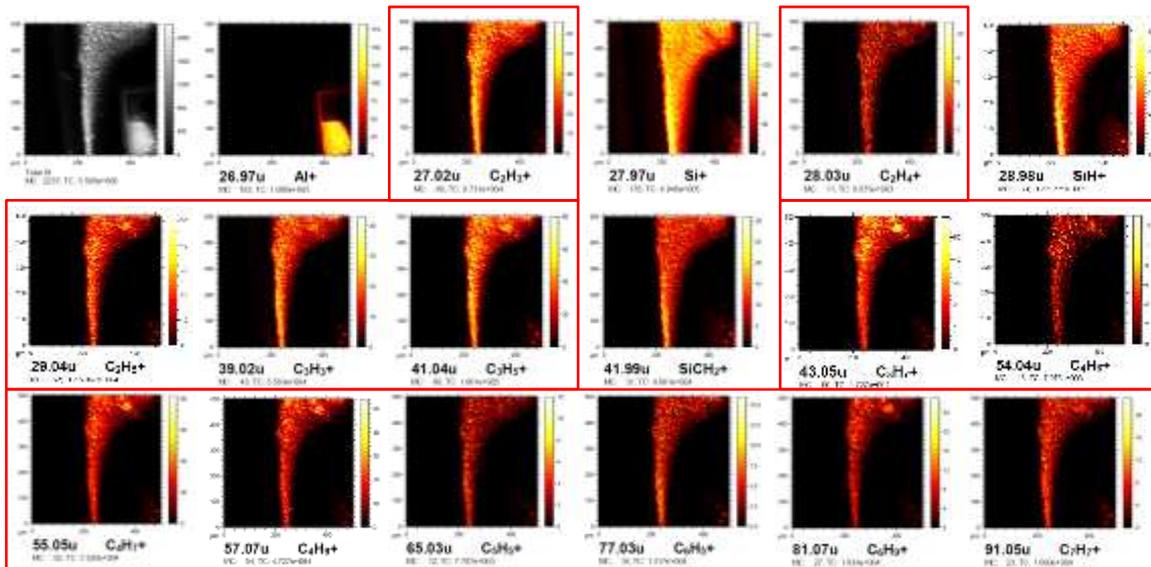
Fig. 5. Positive scan TOF-SIMS molecular fragment maps. Red boxes indicate fragments with organic origin.

There is a pronounced elevation difference of the bond pad area, the ceramic area, the glue and the die, posing a geometric constraint and limiting accessibility. The sample was tilted to maximize the signal, making the ROI accessible despite the geometric constraint. The bond pad area was excluded due to the loss of signal from the ceramic area when bond pad is part of the ROI. The loss of signal is due to the geometric constraint. The positive and negative scans confirm the presence of organic residues on the EBO area. Organic fragments ( $\text{C}_x\text{H}_y$  and  $\text{C}_x\text{H}_y\text{O}_z$ ) on top of the ceramic substrate indicate the presence of the glue resin component. These results are consistent with the FTIR & FESEM-EDS results.

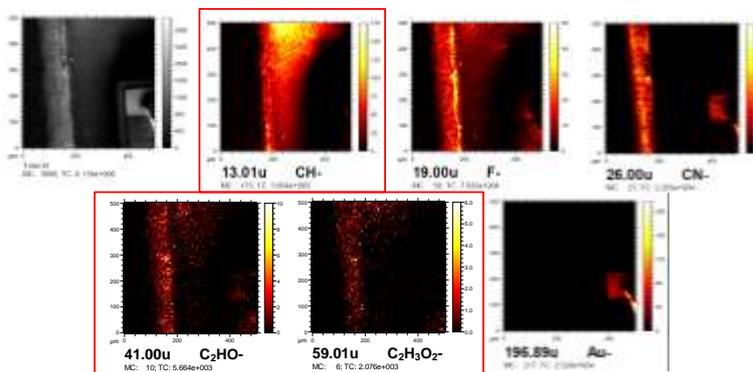
Fig. 6. Negative scan TOF-SIMS molecular fragment maps. Red boxes indicate fragments with organic origin.
