Addressing Package Crack during Frame Mounting by Defining Appropriate Mounting Roller Kit

Alvin S. Soreda, Ernesto T. Antilano Jr.

New Product Development and Introduction, Back-End Manufacturing & Technology, STMICROELECTRONICS, Inc., 9 Mountain Drive, LISP II, Calamba 4027 Laguna, Philippines

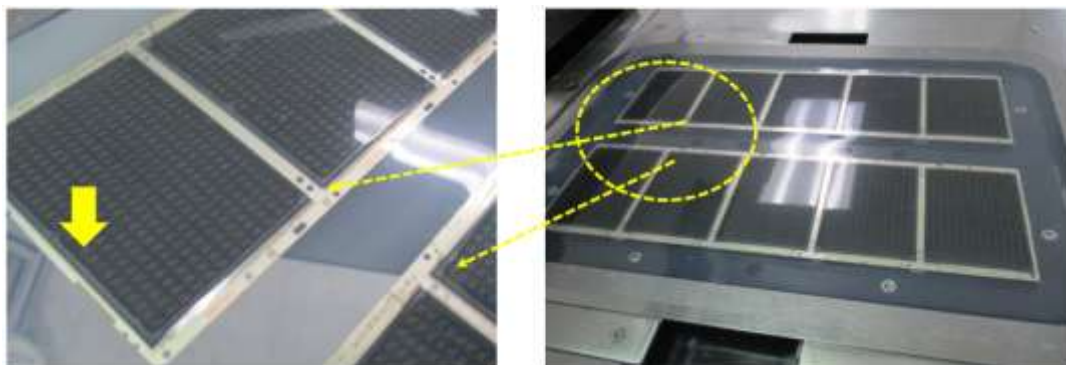
- Package strip to UV tape mounting is required on a tape Package sawing process to hold the strips on the chuck table in order to ensure the sawing stability during the process.
- On a semi-auto mounting process, Soft roller is used to initially applied proper down force pressure contact between UV tape and molded surface of the strip package.
- Figure 1.0 illustrate the mounting process of a typical QFN device with a 0.60mm total package thickness. Due to its thinnest package, the roller unable to apply the required pressure on the whole package area resulting to weak adhesion at the side perimeter of the strip molded package as per illustrated on figure 2.0.

Fig. 2.0 Weak adhesion of Tape on Strip mold surface resulting to manual intervention of User.

- In order to have constant Z-down pressure on both metal ring and on the target package, modification of soft roller has been considered.
 - Proposal 1 on Figure 5.0 below illustrated the new design for thinnest packages to have better contact between UV tape and Strip Package.

- By modifying the soft roller, the thinnest package has constant contact on both metal ring and strip package. Manual intervention of Operator has been eliminated and package crack has been prevented.

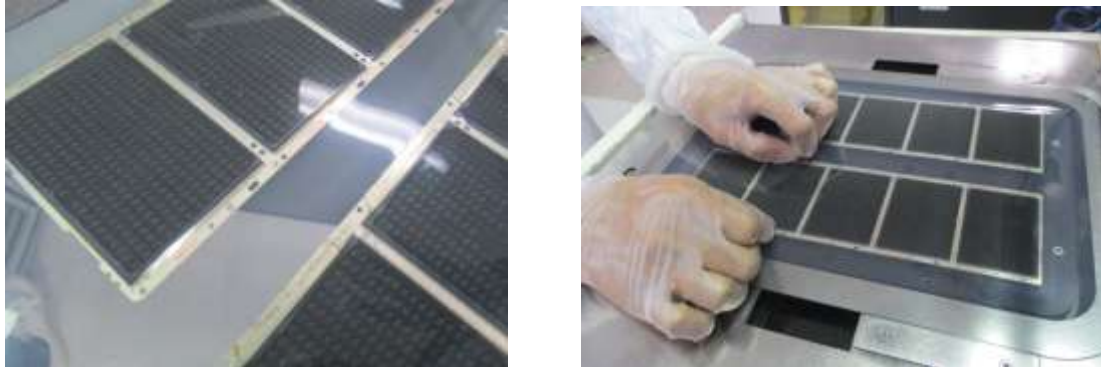
- Mechanical Soft Roller on mounting machine press the UV tape on molded strip package however unable to press the edge of molded area resulting to weak adhesion, therefore, intervention by operator to manually press the affected area as immediate corrective action. On this scenario, the required pressure has been altered by Operator which is depends on his/her aimed force

released. On Figure 3.0 shows manual intervention of Operator performing manually press the weak area of mounted strips by using his/her thumb fingers with undefined pressure resulting to high risk of package crack.

Fig. 3.0 Operator applied pressure on area of strip package affected by weak adhesion.

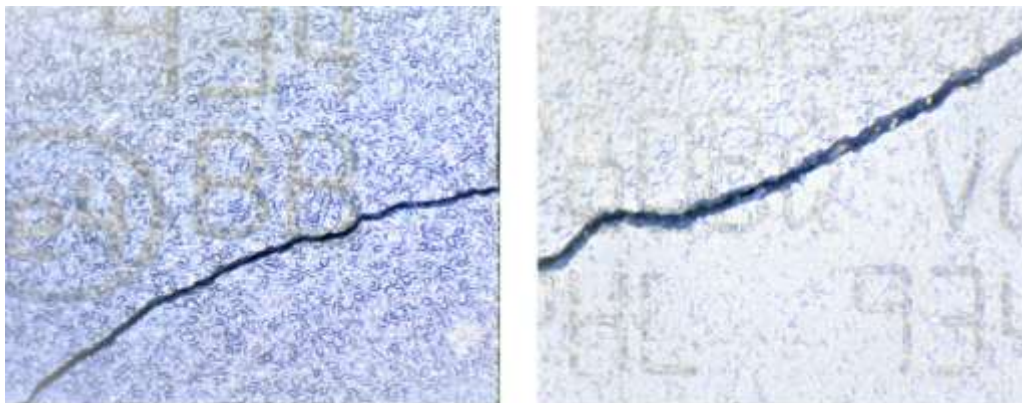
- Units affected by package crack is automatically rejected aside from performing 100% inspection to guarantee that no more units are affected. Non value added activities by performing 100% inspection is additional cost that be shouldered by the units itself. Figure 4.0 shows the sample encountered units with package crack detected at 100% visual inspection after package simulation.

Fig. 4.0 Samples of package crack encountered at 100% VMI.
