LFBGA273 Die Crack Reduction through Mold Process Improvement

Ernani Padilla¹, Lester Belalo²

^{1,2}Back-End Manufacturing & Technology, STMicroelectronics, Inc., Calamba City, Laguna, Philippines 4027

Abstract— In the changing package portfolio of ST Calamba from a major HVQFN plant to a BGA plant, one of the most complex and highest volume package lead type was LFBGA273. This was successfully transferred and qualified to our site but during the large scale volume production it encountered a major quality excursion which is die crack detected at test but was pinpointed to be encountered at mold process.

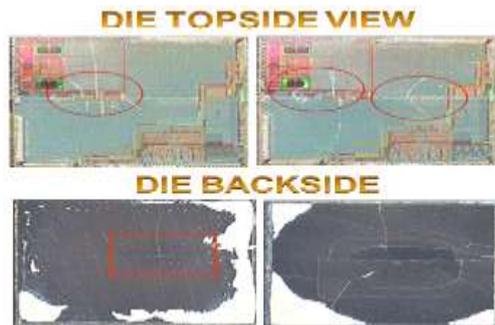
Fig. 5. Top and back view of die crack

Based from the failure analysis of lots with high %OS, open-short, at test. it was confirmed that TN362 and TN500 rejects was due to die crack as shown in the figure 5.

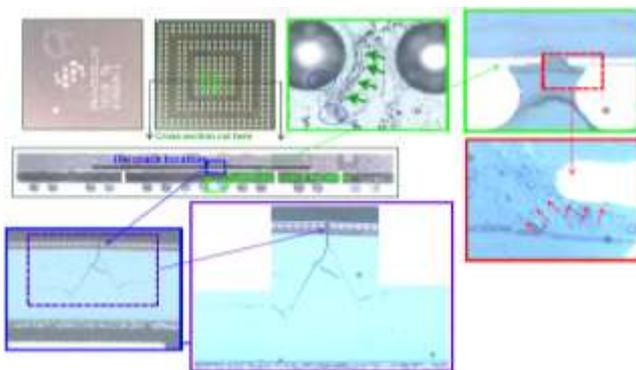
Fig. 6. Die crack high magnification and cross section analysis

Optical inspection showed package dent and substrate crack as indicated by the green arrows. Cross section analysis revealed that the substrate crack propagates to the mold compound surface up to the solder pad as indicated by the red arrows. The location of die crack (blue box) coincides to the location of the substrate crack (green box).

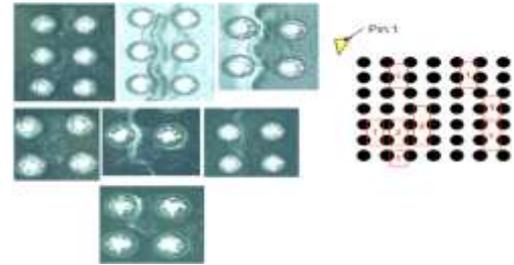
Fig. 7. Actual cull sample for onemap that was broken at degate area

As per mapping all unit with die crack has dents at different location of the unit

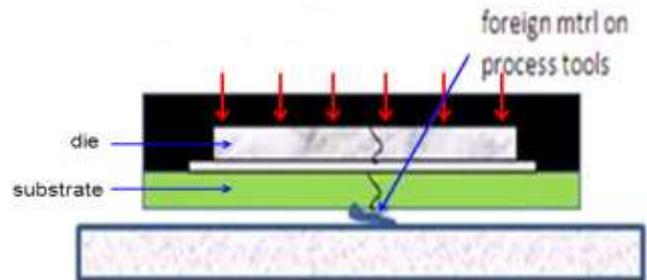
Fig. 8. Illustration on potential failure mechanism

Based from the defect signature possible cause of die crack is protrusion on the surface where unit is substrate is placed with opposing force coming from the top resulting to fulcrum effect.

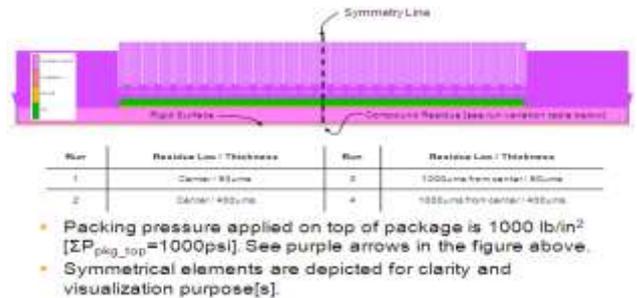
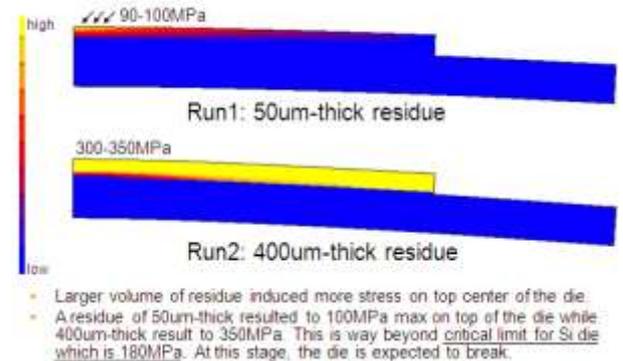
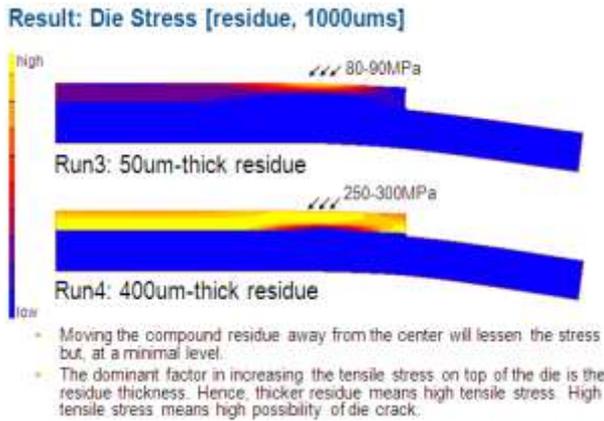
Fig. 9. Finite element analysis modeling for die crack

Compound residue size [thickness] is the dominant factor in increasing the die stress. High die stress means high possibility of die crack. Moving away the compound residue will lessen the die stress but, at a very minimal effect.

Even at 50-um residue thickness, the stress magnitude has already reached 100MPa and increased to 350MPa with a 400um residue. Note that critical limit for silicon die is 180MPa. Which means that it [residue] can accumulate to a higher volume anytime, if not being cleaned.

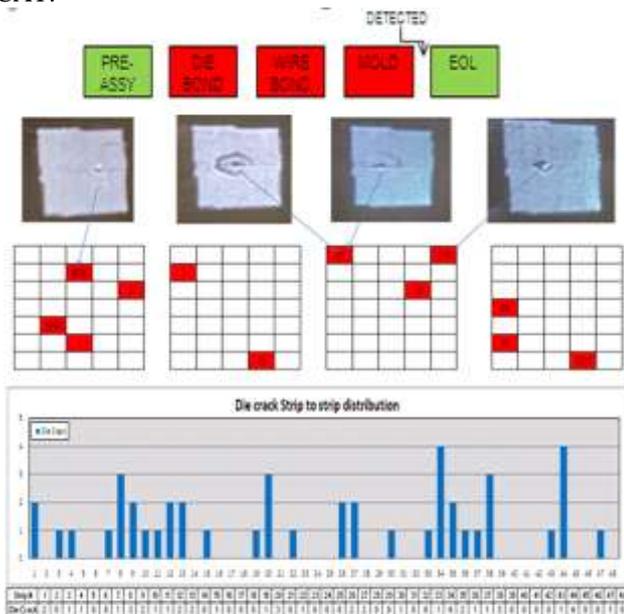
Fig. 10. Die crack process mapping

Conducted process mapping per log point for die crack and results revealed that die crack is seen after mold process via SCAT.

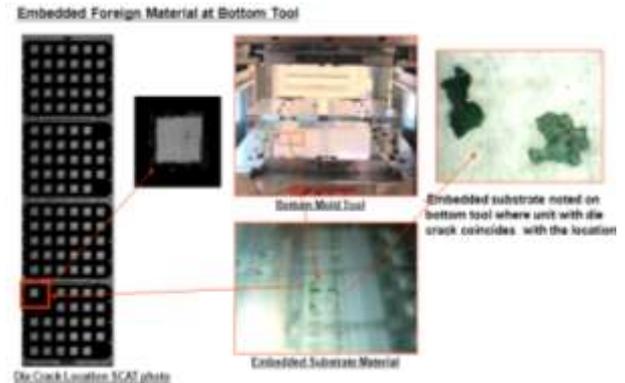
Fig. 11. Mold mapping for die crack

It was observe that substrate solder resist was embedded on bottom tool surface which coincides to the location of die crack during SCAT verification

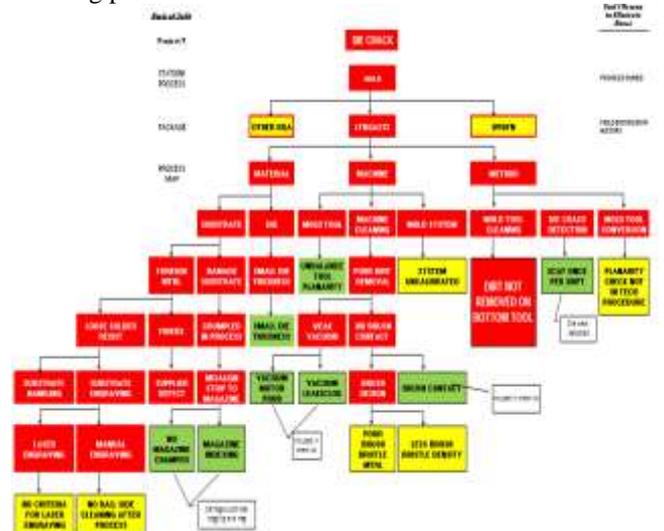
Fig. 13. LFBGA273 die crack fault tree diagram

Based from the fault tree there are several potential root cause of foreign materials at mold that will lead to die crack but not all lead to gross rejection. This is aggravated by the current cleaning capability which prevents cleaning of bottom tool due to restriction of vacuum holes being clogged by the cleaning process.

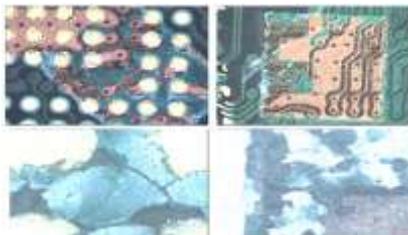
Fig. 15. Loose solder resist from supplier reject

Inspection of lots processed revealed units with bleed of mold compound on substrate backside and loose solder resist on laser engraved substrate rejects.

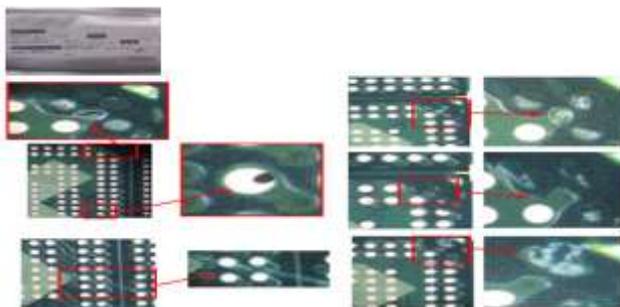
Fig. 16. Fresh substrate inspection result on supplier rejects

Also inspected fresh substrate from same batch revealed damage substrates and foreign material on supplier rejects that can lead to die crack.

With the confirmation of the root cause to be attributed to the affected substrate batch, immediate scrapping of the remaining substrates was executed. Affected lots at test was risk assess to be captured by test program while lots at assembly was subject to SCAT.

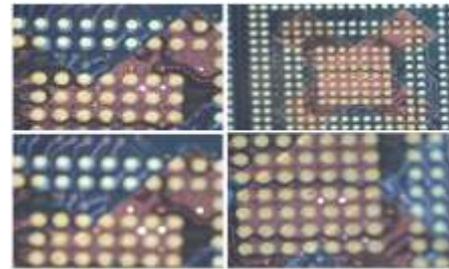
Fig. 17. Pin light penetration test for substrate holes

Pin Light penetration test was also conducted to confirm substrate holes on affected batch. Light penetrated across the engrave part of the substrate

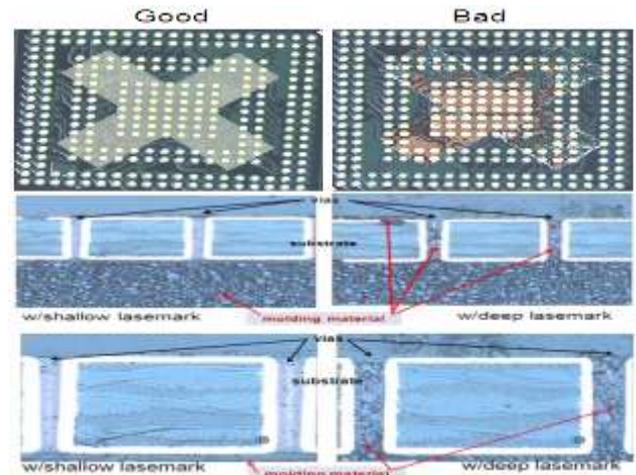
Fig. 18. X-ray and delamination sample for different pellet weight

Based from comparison of good and affected bad parts deep laser engraving was noted on bad parts which leads substrate holes causing mold compound bleed and loose solder resist flakes.

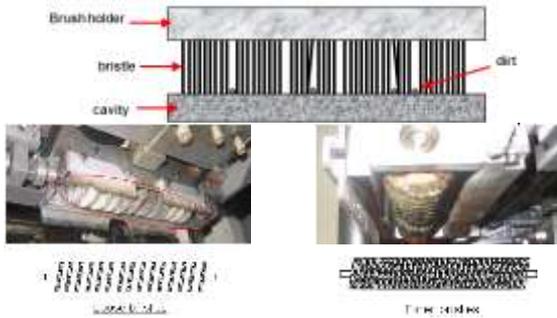
Fig. 20. Mold sweeper brush and bristle configuration

It was observed that not all loose debris are being removed by the sweeper brush and roller features of the mold machine due to the bristle configuration. A purchase order has already been raised to make the bristle design more fine as shown below.
