Adhesive Contamination Removal through Improvement at Package Sawing Process

Alvin S. Soreda, Ernesto T. Antilano Jr.

New Product Development and Introduction, Back-End Manufacturing & Technology, STMICROELECTRONICS, Inc., 9 Mountain Drive, LISP II, Calamba 4027 Laguna, Philippines

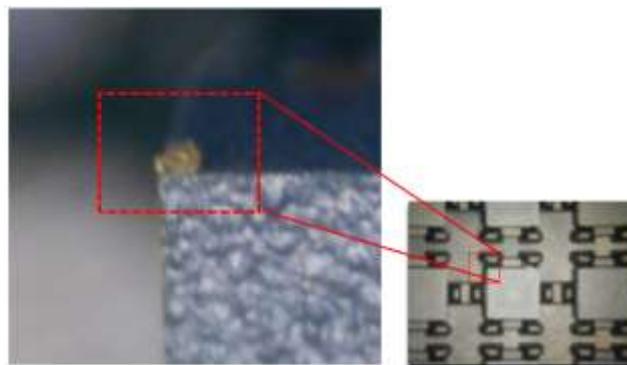
- During Final Visual and Mechanical Inspection, Singulated units already separated on tape and was placed on tray. 100% visual inspection with each lot was applied wherein foreign mat or contaminants was captured as shown on Fig. 1.

- One whole lot was affected, resulting to have a longer visual inspection period due to manual removal of contaminants (adhesive residue from UV tape) per units. Almost 8 hours consumed to totally removed the contaminants and will perform 100% re screening afterwards.

Fig. 1. Actual singulated units with adhesive contamination.

- The occurrence of adhesive contaminants should be tag as reworkable because it is just cosmetic and no internal mechanical stress failure may have encountered to affect product functionality.

- By adjusting the blade spindle revolution (reduced from 30KRPM to 20KRPM), the issue of adhesive contaminants has been resolve. No adhesive contamination on the succeeding lots after implementing the corrective action. Inspection per lot made much shorter time and leads to have production target shipment on time.
- Additionally, by adjusting only the Spindle revolution and maintaining the Feed Speed production UPH will be the same.

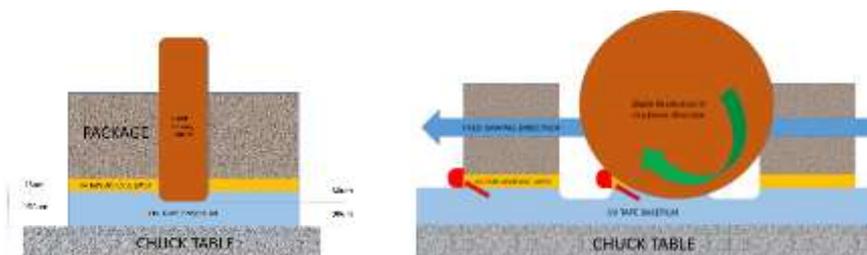
- Figure 2.0 below shows the constructive analysis on why adhesive contaminants or tape whisker is being encountered and formed what associated factors to be investigated.

Fig. 2. Actual failure mechanism.

- As illustrated on Figure 2, three (3) items of factors defined as contributor of adhesive contamination. One (1) is the Spindle revolution, two (2) is the Feed speed and three (3) is the Cut depth or blade height.
- Eliminating factors are need to consider to have a quick response on production needs, considering an engineering solving approach to have a better and constructive solutions. Figure 3 below shows eliminating method done to have quick but best solution to resolve encountered issue.
