# Auger Electron Spectroscopic Analysis of Filler Densification-Induced Interfacial Fracture in Polymer Particulate Composite System

Ian Harvey Arellano<sup>1</sup>, Dexter delos Santos<sup>2</sup>

<sup>1</sup>Central Engineering & Development and <sup>2</sup>Failure Analysis Group  
STMICROELECTRONICS, INC., 9 MOUNTAIN DRIVE, LISP II, CALAMBA 4027 LAGUNA, PHILIPPINES

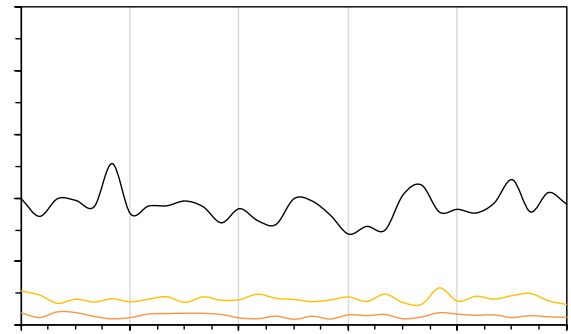
Fig. 4. AES depth profile of the base material surface. Inset: SEM micrograph of the analyzed surface.

Fig. 5. AES depth profile of the glue surface. Inset: SEM micrograph of the analyzed surface.

Results from the base material at the fracture plane suggest homogeneous composition within the 50 nm surface slab (Fig. 4). More importantly, these results indicate that the fracture plane is within the base material layer.

AES results from the glue surface (Fig. 5) indicate remnants of the base material. Elemental depth profile indicate that the fracture plane is mainly organic (5 nm) with Wollastonite ( $\text{CaSiO}_3$ )-rich layer (7 nm) present near the intercalation zone. A 5 nm intercalation zone exists 12 nm from the surface. This intercalation zone is responsible for the

adhesion strength between the polymer of the base material and the glue. It is apparent from the results that the filler material is densified near the fracture plane, suggesting that this densification reduces the resistance of the interface to thermomechanical stress [6]. The softening of the cap surface during thermal treatment and/or the mutual solubility with the glue material causes the localization of  $\text{CaSiO}_3$  at the interface. The higher filler content means that the epoxy content is lower, and hence less material that acts as dispersing medium. In addition, the filler-to-filler contact is higher resulting in weaker resistance to mechanical stress [7-8].

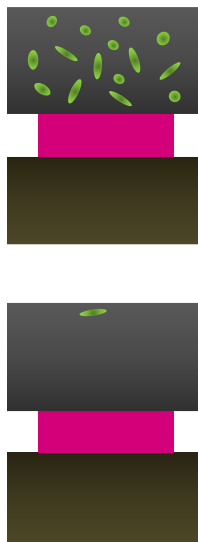
Fig. 6. Proposed mechanism of the filler-densification induced fracture.

The failure mechanism deduced from the results is shown in Fig. 6. In good assemblies, the filler is well dispersed in the epoxy matrix; hence, we speculate that PPC has higher resistance to thermomechanical stresses. The epoxy matrix acts as a cushion to prevent the fracture. However, in the case of the failing units, the densified filler creates a brittle layer sandwiched between the intercalation zone and the epoxy-rich glue matrix. The intercalation zone is expected to be strong because of the polymer (base material)-to-polymer (glue) compatible interaction. However, the interface of the brittle layer and the epoxy matrix (soft) is expected to be weak due to

environment. This weakness translated to fracture, and by extension component failure.
