# Die Attach Pre-bond Optimization for Nickel-Palladium-Gold Roughened Leadframe

Michael D. Capili

Back-End Manufacturing & Technology, STMicroelectronics, Inc.  
Calamba City, Laguna, Philippines 4027

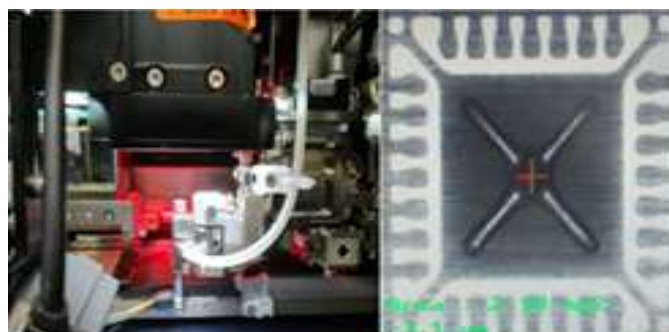
The study on the roughened  $\mu$ PPF utilizing Pre-bond parameter for Ag-based epoxy on standard Ag-plated DAP Cu leadframe causing Pre Bond Inspection Machine cannot fully detect the epoxy pattern, due to dark background image cause by rough leadframe, as showed in Figure 2.

Fig. 2. Roughened leadframe causing Die Attach Pre Bond Inspection Machine cannot fully detect the epoxy pattern.

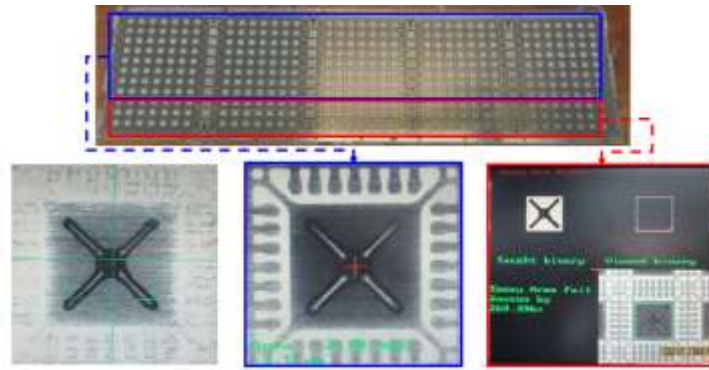
Un-even contrast of pad's, causing pre-bond inspection problem as showed in Figure 3. Hard to teach / set-up epoxy inspection due to no contrast between leadframe die pad vs. epoxy. Roughen leadframe property have different surface contrast causing Frequent "Bond Align" and epoxy inspection error on Roughen leadframe.

This occurrence leads to risks of insufficient epoxy which is detrimental on reliability (delamination on die bottom) and can cause manufacturing yield loss due to insufficient epoxy coverage.

Fig. 3. Un-even contrast of pad's, causing pre-bond inspection problem

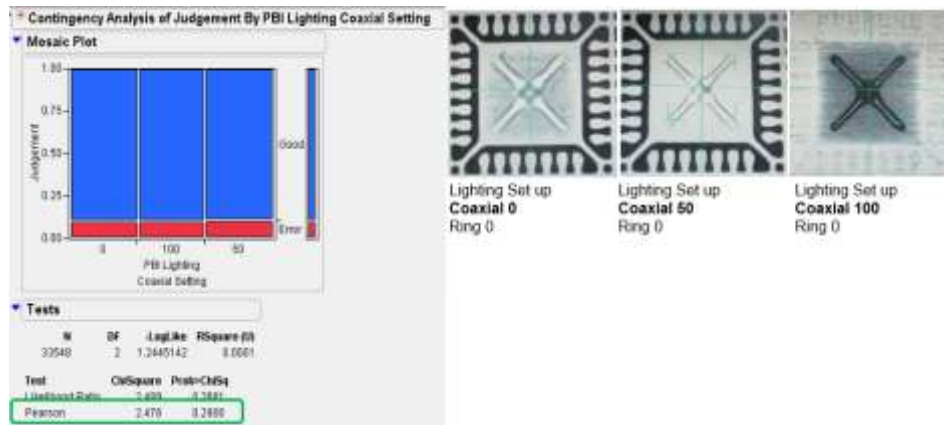
Series of Evaluation were done to analyze and to find optimum solution in Die attach pre-bond inspection using roughened PPF leadframes. At Pre Bond Inspection, different Lighting Coaxial parameter setting will evaluate and test, if they can provide a result of Good judgement of pre-bond inspection. As a result, showed in figure 4, there is not significant difference on the PBI. Machine cannot fully detect the epoxy pattern; some epoxy cannot form complete boundary under strong coaxial.

Fig. 4. Evaluation result on different Lighting Coaxial parameter setting using 2-proportion test

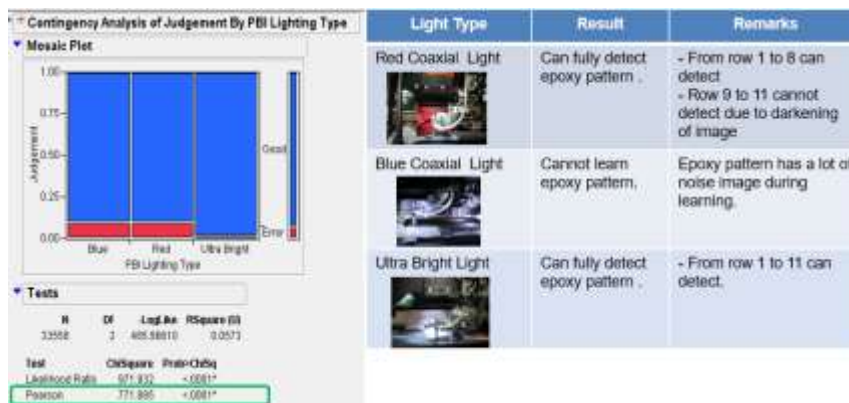
Evaluation on different Lighting Type for Die Attach pre-bond inspection where also done as showed in figure 5. This is check if can resolve PBI problem for PPF leadframe. And the result showed, there is significant difference on the Pre-Bond Inspection result. Ultra Bright light is better compare to Red and Blue Coaxial Light, Rough pattern on pad can be completely removed. As showed in figure 5.

Fig. 5. Evaluation result on different Lighting Type for PBI using 2-proportion test

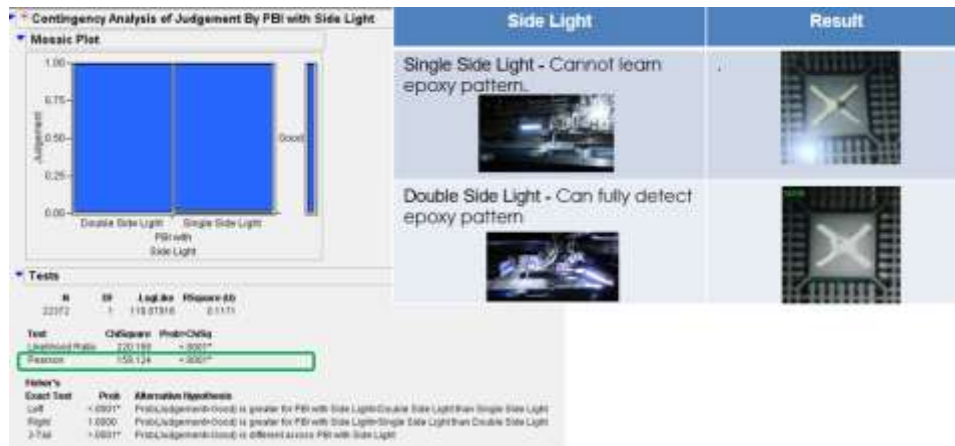
Addition side where also consider and evaluate. To check whether the additional Single or Double Side light, can improve the lighting solution? As showed in figure 6, Double Side light is better PBI result. The Epoxy pattern can be clearly distinguished from the pad, remove the dark shadow.

Fig. 6. Evaluation result on different Side Lighting for PBI using 2-proportion test

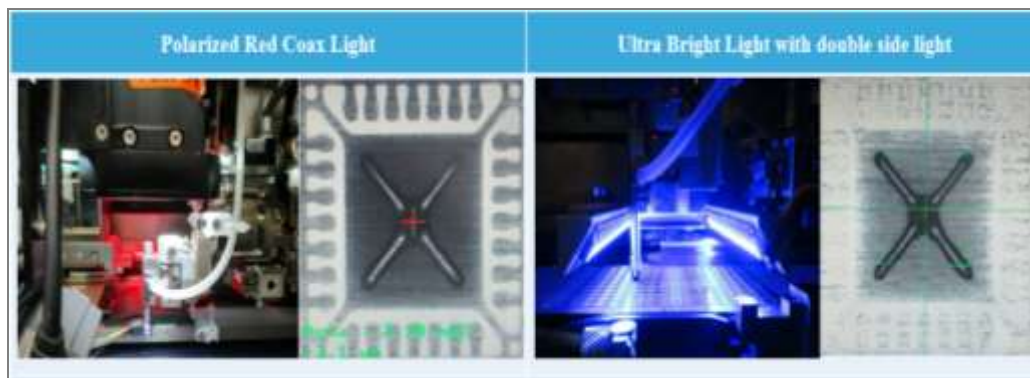
Fig. 7. Improved Die Attach Pre-bond inspection using Ultra Bright Light with double side light.

Overall evaluation and statistical testing on Pre-bond inspection showed the Ultra Bright Light with double side light is the optimum solution for Un-even contrast of die pad's, causing pre-bond inspection problem as showed in figure 7.

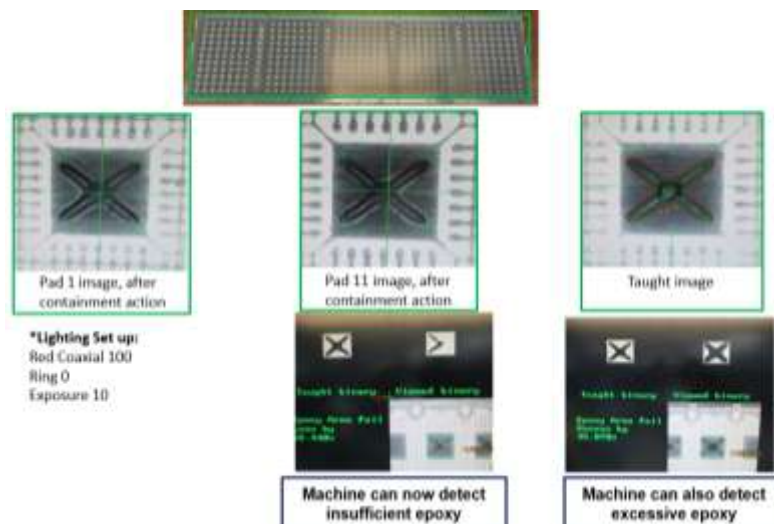
Equal contrast on die pad was attained on bond PRS lighting from pad column 1 to pad 11. Die machine PBI can fully detect the insufficient epoxy dispense pattern, as well as excessive dispense of epoxy, as showed in figure 8.

Fig. 8. Improved Die Attach Pre-bond inspection result.
