Condition Assessment of Concrete in the 2 PSC Girders of the Pipe Conveyor Bridge of 2 X 660 MW Udangudi Super Critical Thermal Power Project at Thiruchendur

Abstract— *M/s ITD Cementation India Ltd, Thiruchendur, intended to assess the condition of concrete in the Prestressed Concrete (PSC) Girders of the Pipe Conveyor Bridge of 2 X 660 MW Udangudi Super Critical Thermal Power Project at Thiruchendur. A consultancy project proposal on 'Condition Assessment of Concrete in the PSC Girders of the Pipe Conveyor Bridge of 2 X 660 MW Udangudi Super Critical Thermal Power Project at Thiruchendur' was submitted by M/s Hitech Concrete Solutions Chennai Pvt Ltd, Chennai. M/s ITD Cementation India Ltd, Chennai confirmed the scope of work and entrusted the work to M/s Hitech Concrete Solutions Chennai Pvt Ltd, Chennai. The site investigation to assess the condition of concrete in the PSC Girders of the Pipe Conveyor Bridge of 2 X 660 MW Udangudi Super Critical Thermal Power Project at Thiruchendur was carried out by M/s Hitech Concrete Solutions Chennai Pvt Ltd, Chennai on 17-09-2019. This report outlines the details of the site investigation carried out to assess the quality of concrete, an

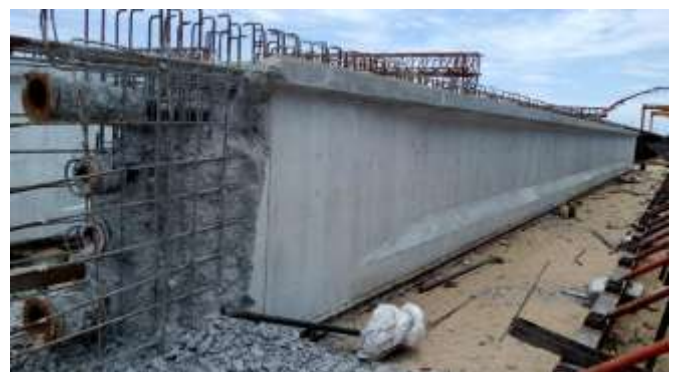
Fig. 1. View of the PSC Girders of Pipe Conveyor Bridge of 2 X 660 MW Udangudi Super Critical Thermal Power Project at Thiruchendur

The Girders tested were Prestressed Concrete (PSC) I Girders of the Pipe Conveyor Bridge of 2 X 660 MW Udangudi Super Critical Thermal Power Project at Thiruchendur. Prestressed Concrete (PSC) I Girders were 33.3 m long and 1.90 m deep. Photo 1 shows a general view of the PSC Girders. Fig. 1 give the layout of the PSC Girder of the Pipe Conveyor Bridge.

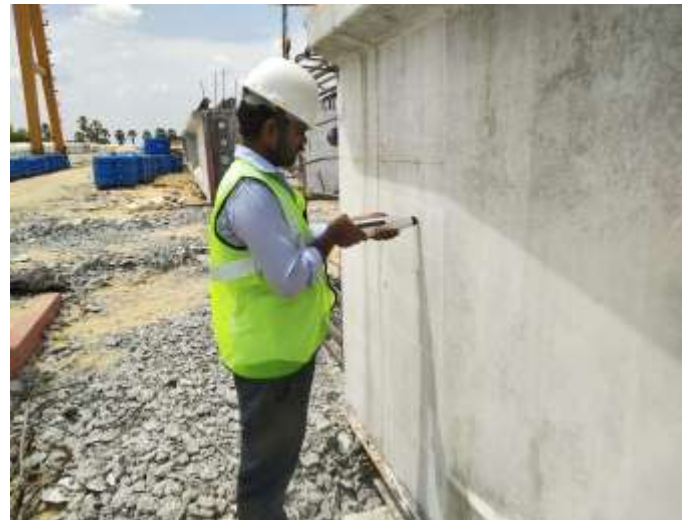
The rebound hammer, which was used in this investigation, was of standard and reliable type, purchased from M/s Proceq SA, Switzerland, i.e., the type 'N' hammer, having an impact energy of 2.2 Nm. Rebound hammer tests were conducted in the selected location of the PSC Girders of the Pipe Conveyor Bridge of Udangudi Project at Thiruchendur, as per IS: 13311 (Part II) - 1992 [1]. The Rebound hammer test was conducted in the presence of the Engineers of M/s ITD Cementation India Ltd. The girders that were tested as well as the test locations was chosen in consultation with the Engineers of M/s ITD Cementation India Ltd. Since there are no available standards for assessing the near surface characteristics of concrete through rebound numbers, the following guidelines have been framed based on the experience gained over a period of 3 decades at SERC, Chennai:

Fig. 2. Photo 2 shows a view of the Rebound hammer test in progress in a PSC Girder.

It is found from Table 1 that the average Rebound Hammer values in the selected locations of the PSC Girders G23R/5 & G23R/6 of the Pipe Conveyor Bridge are 37 and 40 respectively, indicating that the quality of concrete in the near surface portion is “Good”.

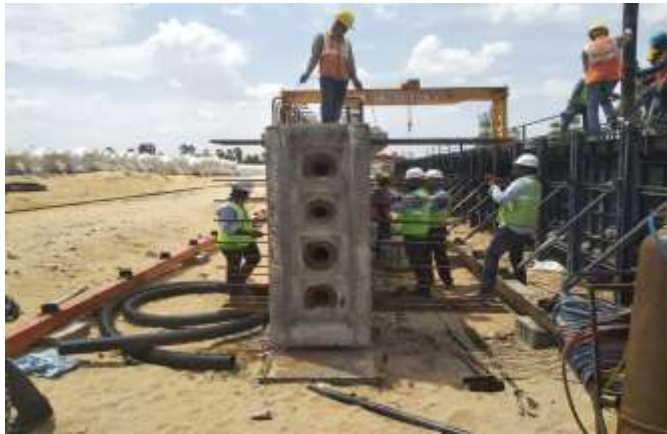
ultrasonic pulse, the ultrasonic wave would get scattered and the pulse may not reach the receiving transducer. In such cases, readings on the PUNDIT would be unstable. In the present investigation, direct (Photo 3) method of measurement was adopted for the PSC Girders. The PSC Girders and the test locations were identified by M/s ITD Cementation India Ltd.

Fig. 3. View of the Upv Test In Progress In A Psc Girder By Direct Method Of Measurement

It is found from Table 2 that the average UPV value in the selected locations of the Girder G23R/5 of the Pipe Conveyor Bridge are above 4.5 km/s indicating that the integrity of concrete can be considered as ‘Excellent’ as per the guidelines of IS: 13311 (Part I)- 1992. It is also found from Table 2 that the average UPV value in the selected locations of the Girder G23R/6 of the Pipe Conveyor Bridge are between 3.5 km/s and 4.5 km/s indicating that the integrity of concrete can be considered as ‘Good’ as per the guidelines of IS: 13311 (Part I)- 1992.
