# Waste Management Strategy in Lewotobi Volcanic Eruption Refugee Camp, East Flores, Indonesia

**Abstract**—The eruption of the Lewotobi Laki-laki volcano not only had an impact on infrastructure damage so that a large number of residents were forced to evacuate. This study aims to identify the condition and quality of sanitation system services in refugee camps. Data inventory of the availability and condition of technical sanitation infrastructure at the refugee base camp was collected during the implementation of thematic real work lecture activities. In addition, interviews were also conducted with refugees and public service officers at the refugee location regarding aspects of behavior, funding support and sanitation system management. The results of this study indicate that in general the availability of technical infrastructure for waste, domestic wastewater, and clean water is quite adequate, but in the long term the existing sanitation management system has the potential to cause environmental health problems, both due to the pattern of handling solid waste and domestic waste and especially due to the pattern of disposing of feces into holes in the ground.

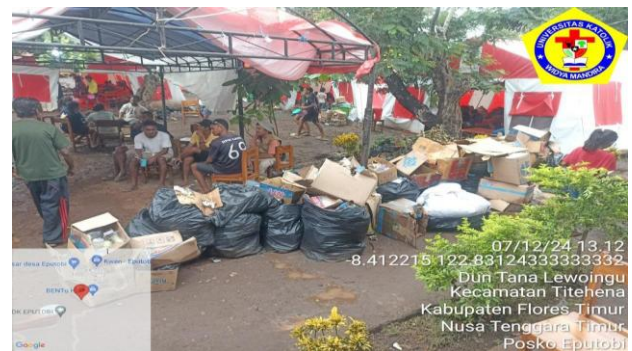
Fig. 2. Temporary solid waste landfill at refugee basecamp

It can be seen that solid waste is put into plastic bags to be transported and disposed of regularly. The results of observations show that daily waste production is fluctuating. The schedule for transporting and disposing of waste is set 3 times a week. Consequently, sometimes there is an unpleasant odor due to organic waste or food scraps and/or general kitchen waste.

Accordingly, it is strongly recommended to: 1) prepare an education team on waste reduction and/or waste sorting patterns for refugees 2) increase the number of waste collection fleets and/or increase the number of trips by waste collection vehicles 3) The East Flores government already has a Fecal Sludge Processing Installation [6] so that if the eruption disaster is prolonged, the construction of septic tank-based toilets needs to be implemented.

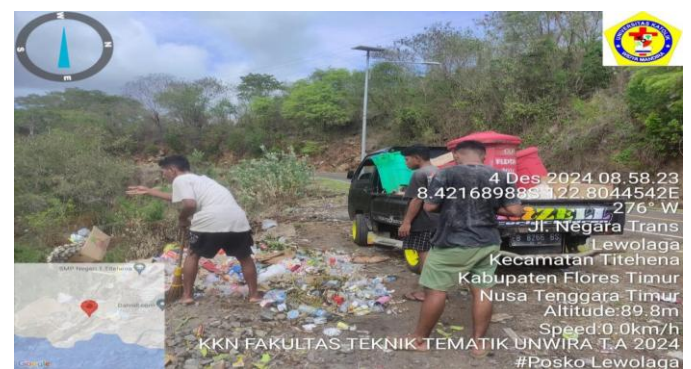
Fig. 3. Illegal solid waste landfill

In addition, the following image clearly shows that the solid waste is not disposed of at the final landfill but is disposed of in the nearest empty land because East Flores Regency does not have a Final Disposal Site. Furthermore, the waste is burned so that it does not cause a bad smell and/or does not become a breeding ground for disease.

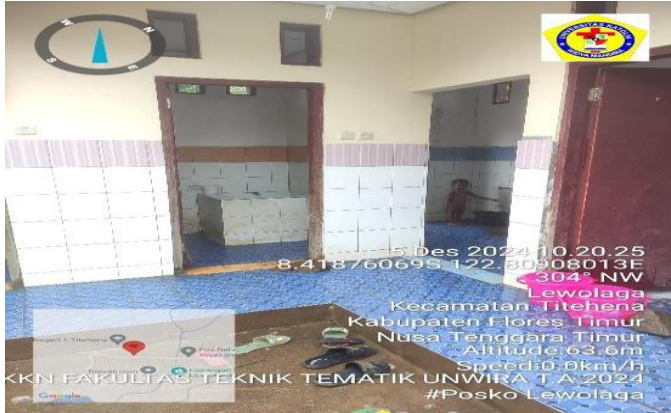
Fig. 4. School-owned bathing-washing-toilet (BWT) facilities

There are several educations (school) as well as religious facilities (church or chapel) surrounding the basecamp so that refugee as well as volunteer may use the available toilets. The toilets were in good condition and using septic tank model.

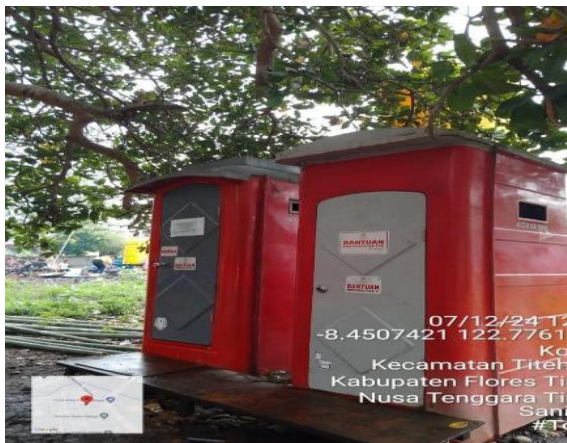
Fig. 5a. Portable Toilet

There are two types of portable toilets as can be seen in Fig. 5a and 5b, respectively. Portable toilets as seen in Figure 5a can be moved from one location to another, but the opposite is true for emergency toilets as seen in Figure 5b. However, both of them do not use septic tanks but instead collect and dispose of feces into holes in the ground. In the short term, the impact of the pattern of disposing of feces into holes in the ground, instead of septic tanks, on environmental health and groundwater quality may not be too big, but in the long term this must be avoided. This is due to the potential for groundwater pollution in the surrounding shallow wells. The potential for pollution is quite large considering the geological conditions of the land which visually look quite porous (karst geology).

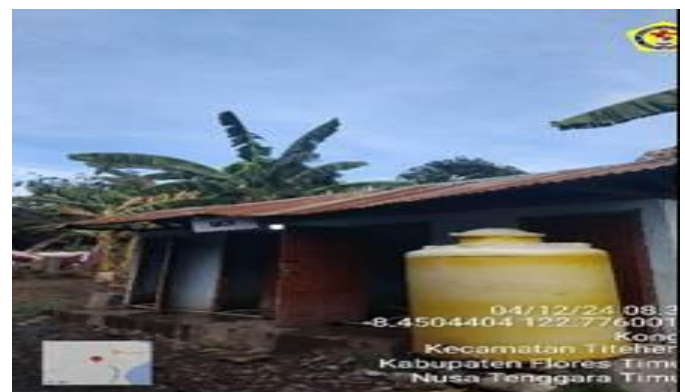
Fig. 6. Type of Local Residence's Toilets

As previously mentioned, there are a large number of elderly refugees, pregnant women and babies who are accommodated in local housing. The condition of the technical sanitation infrastructure (bathing-washing-toilet facilities and clean water storage) is generally inadequate, both in terms of quantity (capacity) and quality.

As a result of these limitations, visual observation results show that there is a number of human feces scattered in empty areas. This strongly indicates the behavior of defecating in random places.

It is thought that the trigger is not only due to the limited number of BWT but also due to the limited capacity of clean water storage. In response to this situation, the local government helped procure water storage tanks in a large number of residents' houses that were used as shelters for the refugees, as can be seen in the following picture.

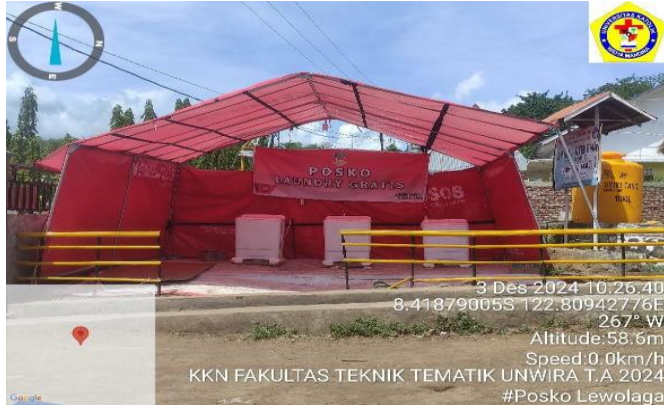
Fig.7 Laundry facility

Alongside the BWT facilities, the government also provides laundry facilities as can be seen in Figure 7 to speed up the process of washing and drying clothes. This was triggered by the minimal ownership of clothes by refugees who left their homes during the eruption in a hurry. Furthermore, from the results of observations and interviews it was found that the supply of clean water by water tanker trucks to support the function of the laundry facilities was quite adequate.

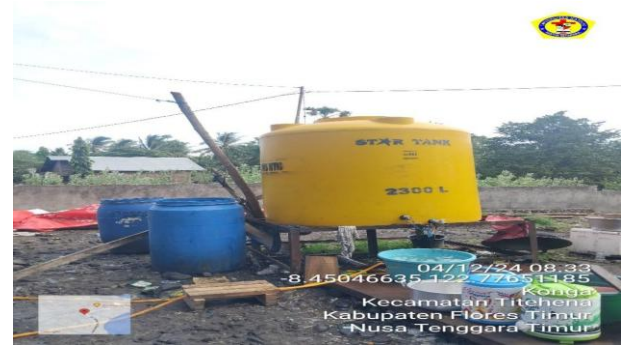
Fig.8 Temporary clean water tank

Clean water supply for refugees is done through aid that has been distributed using water tankers. This water tanker aid comes from various parties including the National Disaster Management Agency, the Indonesian Red Cross, the Army, the Police and other organizations such as local church youth organizations, non-governmental organizations (UNICEF, Plan International and others).
