Auger Electron Spectroscopic Analysis of Filler Densification-Induced Interfacial Fracture in Polymer Particulate Composite System

¹Central Engineering & Development and ²Failure Analysis Group
STMICROELECTRONICS, INC., 9 MOUNTAIN DRIVE, LISP II, CALAMBA 4027 LAGUNA, PHILIPPINES

Abstract— Component failure due to the interfacial adhesion loss is a serious concern in advanced semiconductor packages. Herein, we report the systematic failure analysis performed on a system where one component detaches from the assembly due to the adhesion loss between the base material and the glue. Surface analysis of the fractured surface via scanning electron microscopy – energy dispersive X-ray spectroscopy (SEM-EDS) elemental mapping and Auger electron spectroscopy (AES) revealed that the component failure is due to the densification of the filler in the epoxy-based polymer particulate adhesive. AES depth profiling indicate softening of the base material surface during thermal treatment and/or the mutual solubility with the glue causing the localization of CaSiO_3 at the interface. The densification resulted in the creation of an epoxy-rich meta-stable zone and a filler-rich layer, which reduces

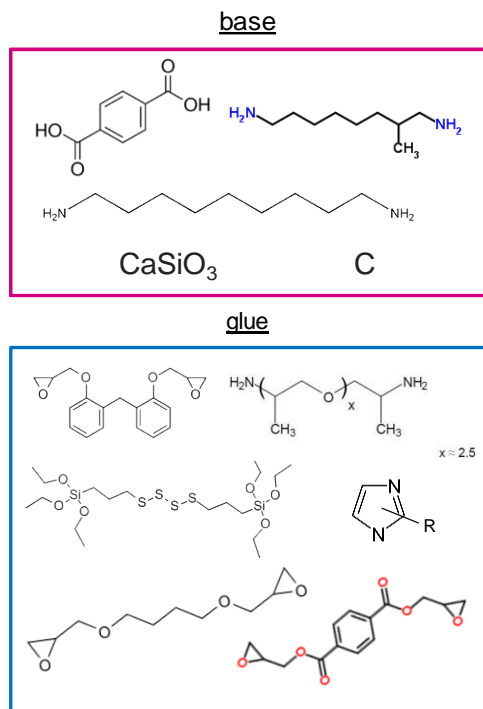
Fig. 2. Chemical structures of the glue and base material components.
