Addressing Package Crack during Frame Mounting by Defining Appropriate Mounting Roller Kit

Alvin S. Soreda, Ernesto T. Antilano Jr.

New Product Development and Introduction, Back-End Manufacturing & Technology, STMICROELECTRONICS, Inc., 9 Mountain Drive, LISP II, Calamba 4027 Laguna, Philippines

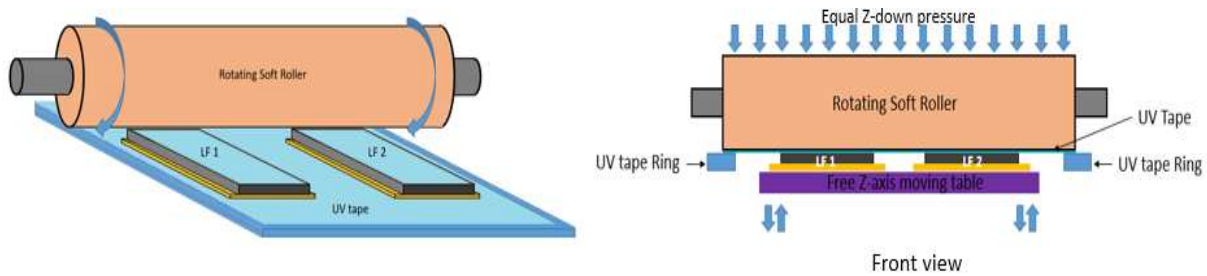
Fig. 1.0 Semi Auto-mounting concept.

- Mechanical Soft Roller on mounting machine press the UV tape on molded strip package however unable to press the edge of molded area resulting to weak adhesion, therefore, intervention by operator to manually press the affected area as immediate corrective action. On this scenario, the required pressure has been altered by Operator which is depends on his/her aimed force

- By modifying the soft roller, the thinnest package has constant contact on both metal ring and strip package. Manual intervention of Operator has been eliminated and package crack has been prevented.
