LFBGA273 Die Crack Reduction through Mold Process Improvement

Ernani Padilla¹, Lester Belalo²

^{1,2}Back-End Manufacturing & Technology, STMicroelectronics, Inc., Calamba City, Laguna, Philippines 4027

Abstract— In the changing package portfolio of ST Calamba from a major HVQFN plant to a BGA plant, one of the most complex and highest volume package lead type was LFBGA273. This was successfully transferred and qualified to our site but during the large scale volume production it encountered a major quality excursion which is die crack detected at test but was pinpointed to be encountered at mold process.

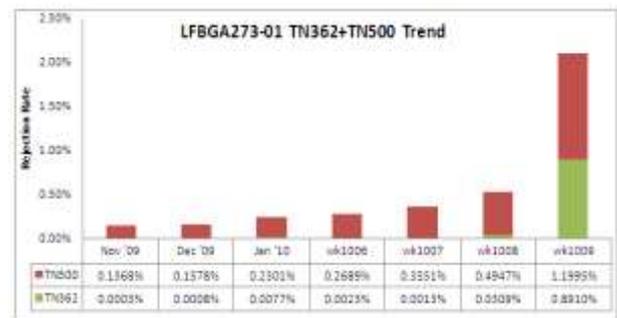
Fig. 3. LFBGA273 Die crack rejection rate at Test

As per LFBGA273 TN362 and TN500 rejection trend increased starting Feb'2010. Note that TN362 and TN500 are test bins for die crack.

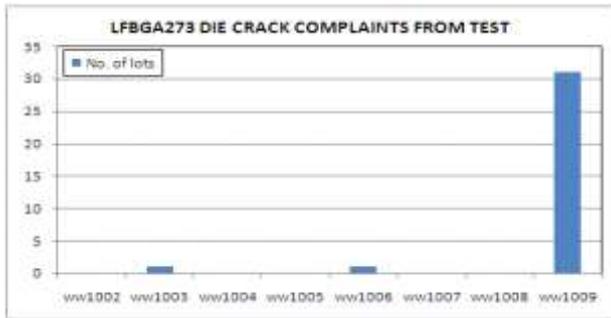
Fig. 4. LFBGA273 Die crack No. of lots trend

This increase of reject rate translate to increase no. of lots affected by die crack which reached a high of 31 lots last ww1009 as shown in figure 5.

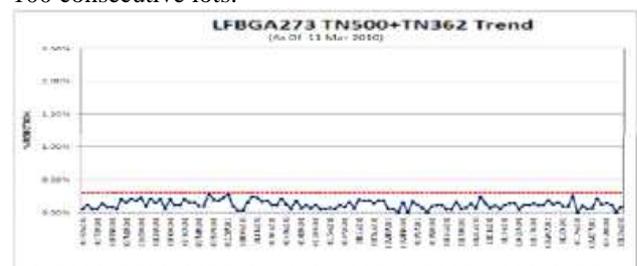
Fig. 19. LFBGA273 Test die crack validation

Effectiveness validation of corrective action was done at assembly via SCAT and confirmed by test results with no lots exceeding 0.3% for TN362 and TN500 test bins on more than 100 consecutive lots.

With the confirmation of the root cause to be attributed to the affected substrate batch, immediate scrapping of the remaining substrates was executed. Affected lots at test was risk assess to be captured by test program while lots at assembly was subject to SCAT.

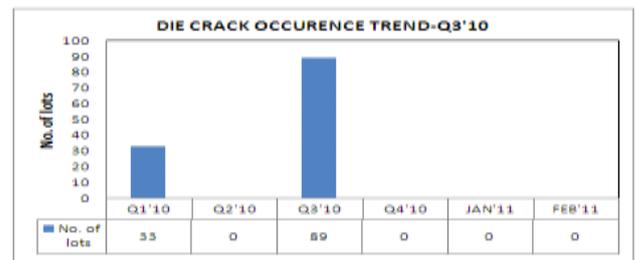
Fig. 22. Die crack occurrence at test trend

To provide real time process control for die crack detection at assembly, it was agreed that SCAT monitoring will be performed every 12 hrs per press per machine. As a result, die crack occurrence at test was zeroed out starting Q4'10 after implementation of mold liner.
