# Auger Electron Spectroscopic Analysis of Filler Densification-Induced Interfacial Fracture in Polymer Particulate Composite System

Ian Harvey Arellano<sup>1</sup>, Dexter delos Santos<sup>2</sup>

<sup>1</sup>Central Engineering & Development and <sup>2</sup>Failure Analysis Group  
STMICROELECTRONICS, INC., 9 MOUNTAIN DRIVE, LISP II, CALAMBA 4027 LAGUNA, PHILIPPINES

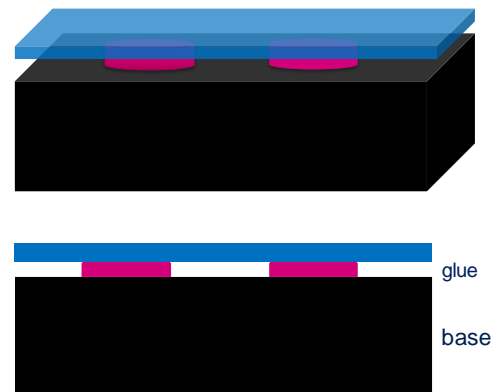
Component assembly was performed using optimized parameters established using elaborate design of experiment (DOE) that is outside the scope of this report. Two surfaces were attached using a non-conductive glue (NCG) as shown in Fig. 1. Detachment of the two surfaces was observed in several components, wherein the fracture was observed along the base material and glue region. A systematic failure analysis was conducted using Philips XL30 scanning electron microscopy - energy dispersive X-ray spectroscopy (SEM-EDS) elemental mapping and JEOL JAMP-9500F Field Emission Auger Microprobe Auger electron spectroscopy (AES).

Fig. 1. Schematic representation of the attachment of two surfaces using epoxy glue.
