Reduction of Copper(II) Oxide on Bare Leadframe Through N₂ Atmosphere Curing

Back-End Manufacturing & Technology, STMicroelectronics, Inc.
Calamba City, Laguna, Philippines 4027

Keywords—Semiconductor; Oxidized; leadframe; nitrogen gas
QFN Quad Flat No leads

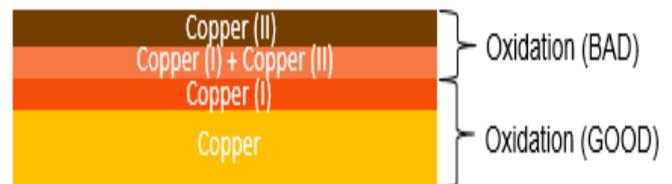
- The excessive oxidation rate of bare copper leadframe during IC assembly is the cause of reliability issue such as delamination.
- Two section of IC assembly is identified to contribute to the excessive growth of oxide: Die attach cure and Wirebonding which both uses higher temperature (>150°c) during process.
- The oxidation is categorized into 2 compound: Copper (I) oxide which is identified as good oxide while Copper (II) oxide is brittle in structure and easily delaminates.

Fig. 2. Oxidation of Copper Leadframe

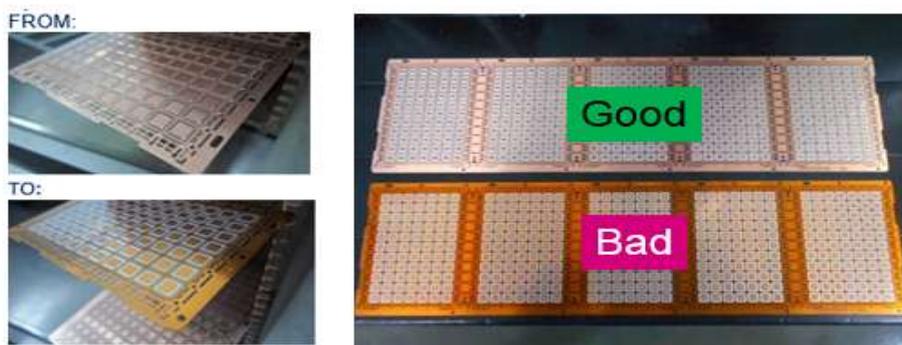
- A modification in the current assembly procedure is proposed to minimize the occurrence of excessive oxidation for copper leadframe.
- N₂ (Nitrogen) atmosphere oven is used to replace conventional oven during curing. Nitrogen is supplied to the internal chamber of the machine bringing down the PPM level of oxygen before the temperature reaches the curing temperature of the glue.
- In Fig. 3 shows an example of oxidized copper leadframe after curing. The change in color for the copper leadframe signifies the presence of oxidation.

Fig. 3. Leadframe status after curing process
