Road Performance Evaluation Due to Office Construction: A Case Study Biola Road in Samarinda

Sakila Herfiana Silmy Adani, Ludfi Djakfar, and Achmad Wicaksono, "Road Performance Evaluation Due To Office Construction : A Case Study Biola Road In Samarinda" *International Research Journal of Advanced Engineering and Science*, Volume 4, Issue 4, pp. 138-141, 2019.

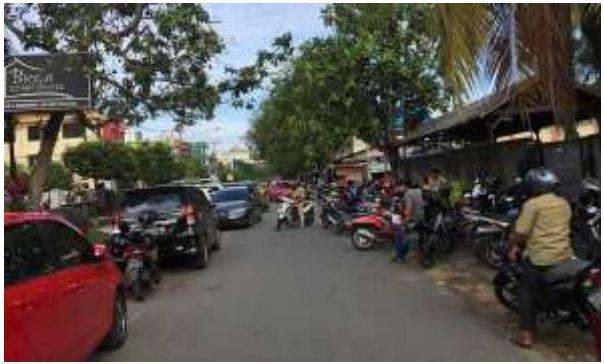
Fig. 1. the use of road shoulder as a parking lot

These activities will affect the traffic with vehicles going in and out of the office, and using the shoulder of the road as a parking lot. This will cause a decrease in the performance of roads, and increase delays. Side barriers on the shoulder of the road are also getting higher due to the presence of quite a number of street vendors.

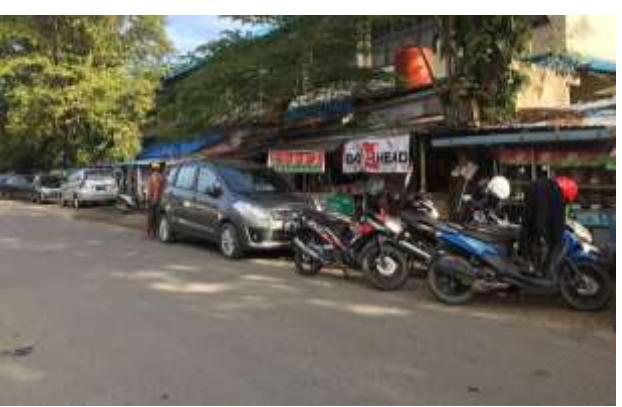
Fig. 2. The use of the shoulder of the road by street vendors

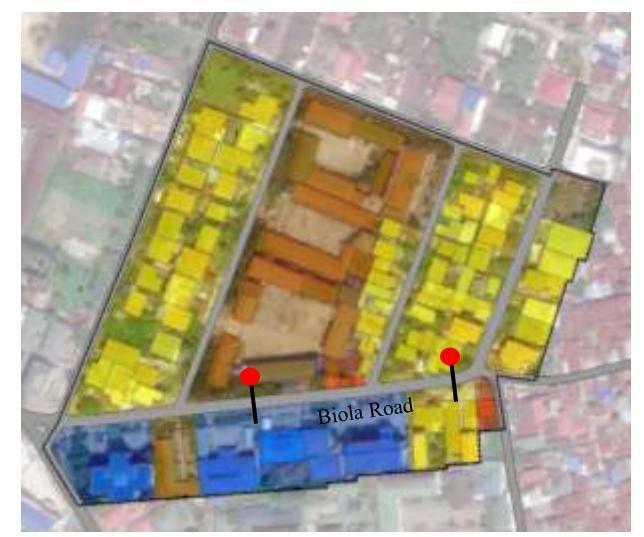
Fig. 3. Location of violin roads and survey points

This research was conducted by reviewing the volume of vehicles on the Biola road and surveying the side obstacles on the road including in and out vehicles, parking vehicles, pedestrians, and slow-moving vehicles. The survey in this study was conducted on 1 effective day (Monday) and 1 holiday (Saturday), at 6:00 to 18:00.
